# Manhole Inspection Summary

Manhole # S35A\_\_020MH

Insp Date: **8/21/08 10:53 AM**

**Location** Address: **210 guilford ave**

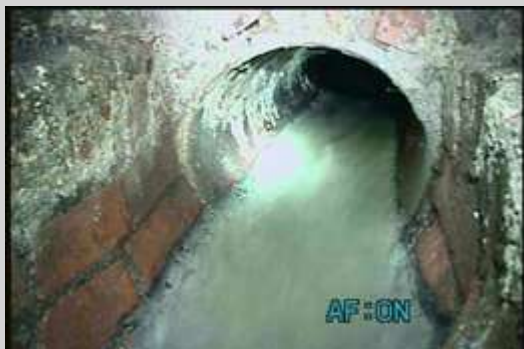
3 O'Clock Inflow

10 in. Circular Gravity Sewer  
Pipe In @ 3 O'Clock

Deposits: ☒ **None** ☐ Mud ☐ Sludge ☐ Debris ☐ Grease

Infiltration: **None** Pipe Seal Cond: **Unknown**

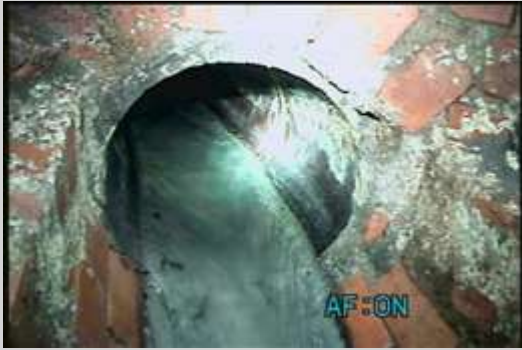
9 O'Clock Inflow

10 in. Circular Gravity Sewer  
Pipe In @ 9 O'Clock

Infiltration: **None** Pipe Seal Cond: **Unknown**
